# Washington Department of Ecology

## Everett Smelter Site

### Summer 1999 Cleanup

#### Details of Cleanup Activities

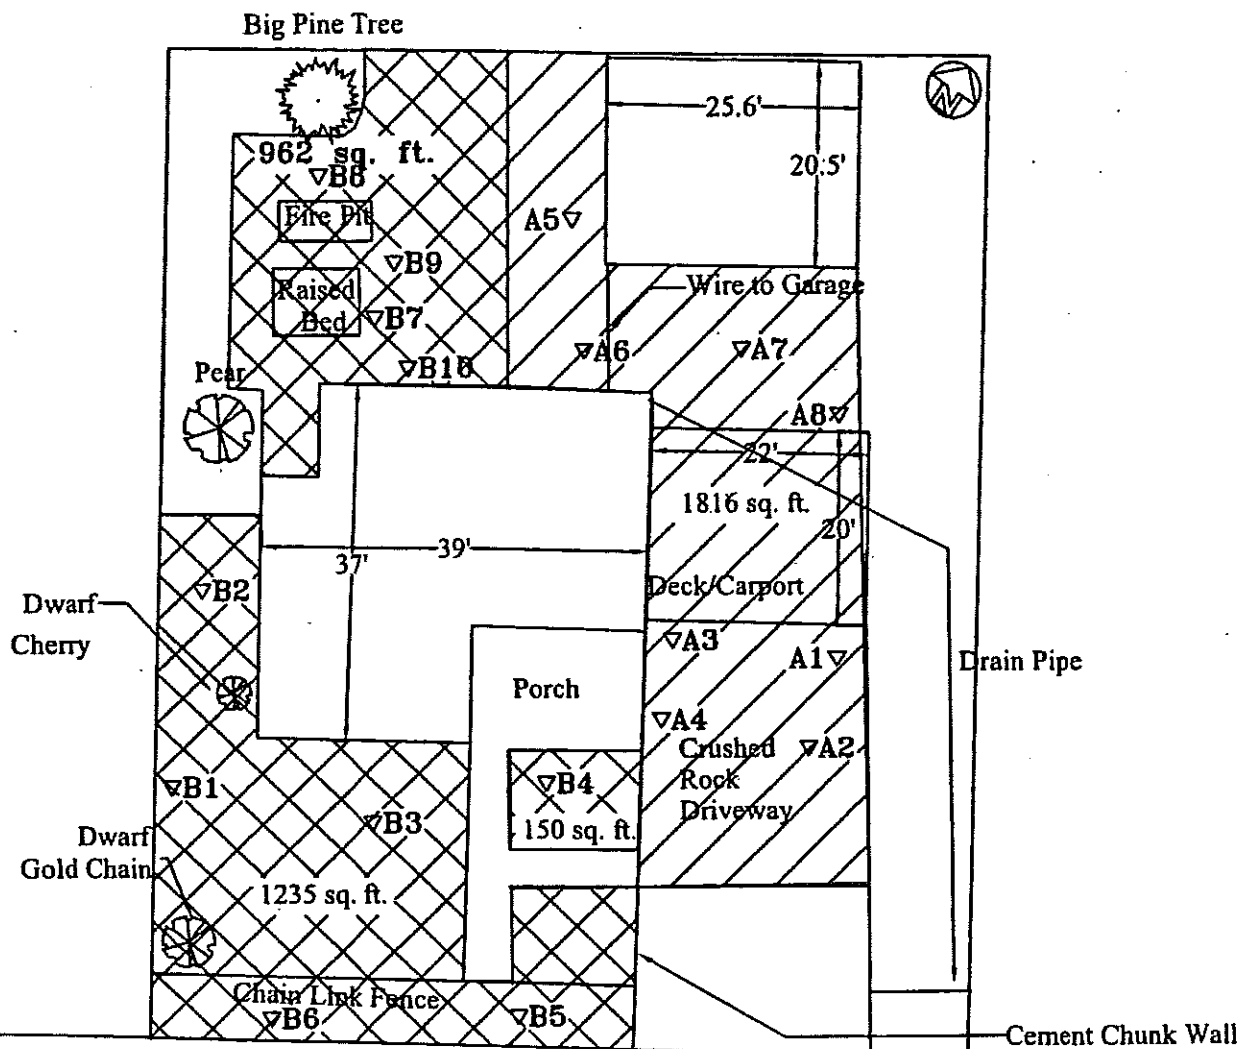
This property was divided by Ecology into two Decision Units, A and B, as shown on the attached map, for purposes of pre-cleanup sampling and decision-making regarding the depth to which excavation was required. The following is a summary of the work done in the remediation of the property within each of the decision units.

Field measurements by the Ecology on-site coordinator confirmed that soil was removed to a depth of 24 inches. Within the dripline of trees, only the existing sod was removed; beyond the dripline, 24 inches were excavated. The combined area of what is shown on

Attachment A as a crushed rock driveway, and the area beneath the deck/carport, was to be completed with an asphalt surface, per the owner's request. Therefore, this area was excavated to a depth of 6 inches, and replaced with 4 inches of crushed rock and a 2-inch layer of asphalt. Backfilling with clean backfill material was carried out, as described in the *Specifications for Everett Residential Soil Remediation*, in the backyard portion of the decision unit. Topsoil was then placed in that area, and sod planted.

Field measurements by the Ecology on-site coordinator confirmed that soil was removed to a depth of 24 inches. No soil was removed from beneath the porch at the front of the existing house, and 12 to 18 inches were removed from over the water line running from the valve in the front yard toward the house, along a line perpendicular to the front of the house, and from the same valve toward the front walkway, parallel to the chain-link fence. The front walkway was not removed during excavation. Soil was not removed from beneath the row of bushes along the northeast boundary of the property. After placing a geofabric marker, backfilling with clean backfill material was carried out, as described in the *Specifications for Everett Residential Soil Remediation*. Topsoil was then placed, sod planted, and fences re-installed. The Gold Chain tree near the southern corner of the property was replaced.
